Effect of Powder Recycling on the Fracture Behavior of Electron Beam Melted Alloy 718

EFFECT OF POWDER RECYCLING ON THE FRACTURE BEHAVIOR OF ELECTRON BEAM MELTED ALLOY 718

H. Gruber, P. Karimi, E. Hryha, L. Nyborg

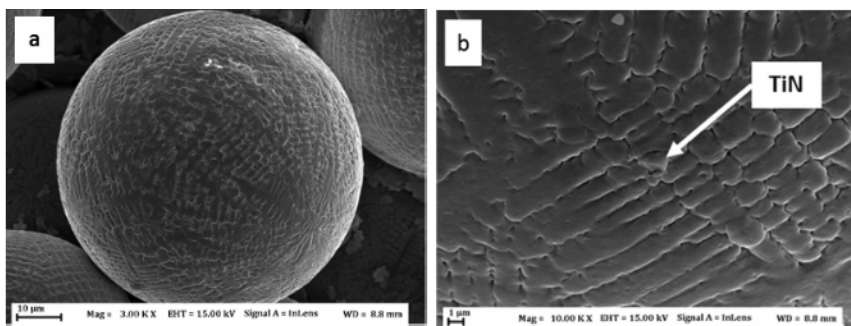
High-resolution scanning electron microscopy of the virgin and recycled powder was done to detect alterations in the powder surface chemistry and morphology connected to multi-cycle powder re-use. Representative surface morphologies of virgin and recycled powder are shown in Figure 2 and 3, respectively. In its virgin state, the powder generally consists of mostly spherical particles with a relatively clean appearance. Even though observed on relatively rare occasions, the virgin powder contains non-metallic inclusions, mainly Ti-rich nitride particles, being around a few μm in size (see Figure 2b). In general, however, the virgin powder surface shows only little presence of secondary phases and surface contamination, even at very high magnifications. However, already after the first build cycles, nano-sized secondary phase particulates start to form on the powder surface and tend to grow with increasing number of re-use cycles. After 14 build cycles, a considerable portion of the powder surface is covered by such particulates, as shown in Figure 3a. Even though their small size does not allow for quantitative chemical analysis by EDX, the clear enrichment in aluminum and oxygen as compared to the matrix material (see Table 2) indicate them as Al-rich oxide particles. A more detailed analysis of the powder material from a selection of the performed build cycles can be found elsewhere [10].

Fig.2. Surface morphology of the virgin powder.

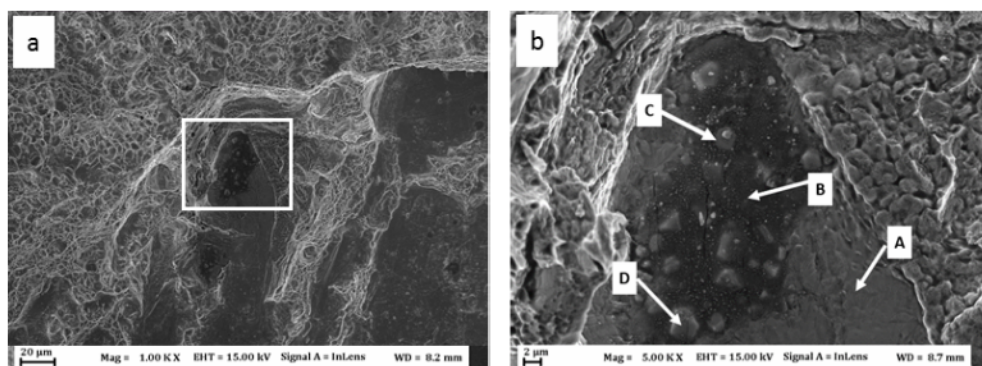
Fig.5. (a) Contour region on the fracture surface of a CVN test sample produced from virgin powder. (b) Higher magnification of denoted region showing oxide covered area with the presence of non-metallic particles. Corresponding EDX analysis data are presented in Tab.3.

Table 3. EDX analysis data from areas in Fig.5b.

Location	Structure	Chemical composition									
			Ni	Cr	Fe	Nb	Mo	Ti	Al	N	O
A	Gamma matrix	wt. %	51.6	18.7	19.2	5.3	3.1	1.3	0.8	-	-
		at. %	50.9	20.8	19.9	3.3	1.9	1.6	1.7	-	-
B	Al-rich oxide film	wt. %	1.1	1.2	0.7	-	-	9.7	44.1	-	43.2
		at. %	0.4	0.5	0.3	-	-	4.4	35.6	-	58.8
C	Al-rich oxide particle	wt. %	10.7	5.4	4.1	5.0	-	10.8	31.7	-	32.3
		at. %	4.8	2.7	1.8	1.4	-	5.9	30.7	-	52.7
D	Ti-rich nitride particle	wt. %	1.8	0.7	0.7	5.0	-	74.2	0.6	13.4	3.4
		at. %	1.1	0.5	0.5	1.9	-	54.3	0.8	33.5	7.4

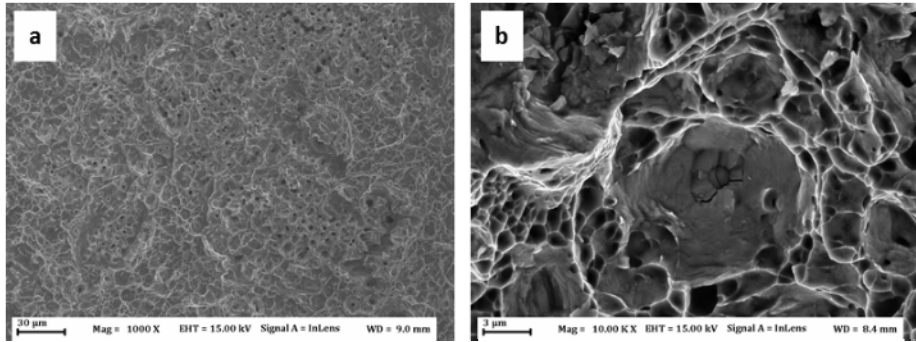
Figure 7 shows the fracture surface in the hatching region of a sample produced from virgin powder. Generally, it consists of fairly equiaxed dimples, indicating ductile failure occurring through microvoid coalescence. Residual porosity, TiN and oxide particles, acting as micro-void nucleation sites were occasionally observed inside the dimples. In Figure 8, the corresponding images from a sample produced from recycled powder show presence of aluminum-rich oxide clusters (denoted area in Figure 8a) sizing up to around 50 µm. It is realized that the size and shape of the individual oxide particulates are very similar to the particulates observed on the recycled powder surface (Figure 3b). However, whether these particles are directly transferred from the powder feedstock or rather re-nucleated and clustered together in the melt pool has to be further elaborated. As already mentioned, weak bonding between oxide and metal and also different elastic properties may result in de-bonding and subsequent coalescence of the voids formed under tensile loading. Even though considerable amounts of defects were present in these samples, a major part of the fracture surfaces has dimple character. This shows that a considerable amount of plastic deformation took place during fracture, indicating an overall ductile fracture in a large portion of the sample. Anyhow, it is well known that that presence of agglomerates of non-metallic particles can have a significant negative effect on fatigue properties. Smaller sized agglomerates, similar to those observed in the hatch regions, may act as crack initiation sites in the high to very high cycle regime [11], whereas larger sized inclusions (preferentially observed close to the contour region) has been reported to be the main cause for fatigue life scattering in the low cycle regime [12]. Therefore, the larger amount of mainly oxide-containing defects in the samples produced from recycled powder shows that powder recycling may have a negative effect on the cleanliness and therefore also on the structural integrity of EBM processed Alloy 718, especially under dynamic loading. Hence, further research is needed to increase the knowledge about imperfections in AM built components, concerning both defect formation and their effects at different loading conditions, preferably using more sophisticated techniques such as fracture toughness and/or fatigue testing.

Fig.7. Hatching region on the fracture surface of a CVN test sample produced from virgin powder.

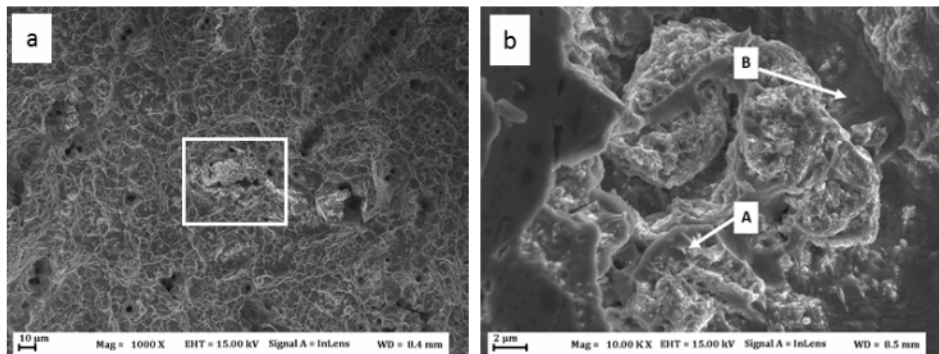
Fig.8. (a) Hatching region on the fracture surface of a test sample produced during cycle 14. (b) Higher magnification of denoted region showing aluminum rich oxide cluster. Corresponding EDX analysis data are presented in Table 4.

Tab.4. EDX analysis data from the areas in Fig.8b.

Location	Structure		Chemical composition,							
			Ni	Cr	Fe	Nb	Mo	Ti	Al	O
A	Aluminium-rich oxide	wt.%	19.4	8.5	7.9	3.4	2.1	2.1	25.5	31.2
		at.%	9.1	4.5	3.9	1.0	0.6	1.2	26.1	53.7
B	Gamma matrix	wt.%	51.8	19.4	19.4	4.7	2.8	0.9	1.0	-
		at.%	50.7	21.4	20.0	2.9	1.7	1.1	2.1	-
